**LOWER HART POND DAM
CT 00247**

**PHASE I INSPECTION REPORT
NATIONAL DAM INSPECTION PROGRAM**

FEBRUARY, 1981

Identification Number:	CT 00247
Name:	Lower Hart Pond Dam
City:	Berlin
County and State:	Hartford County, Connecticut
Stream:	Mattabasset River
Date of Inspection:	October 21, 1980

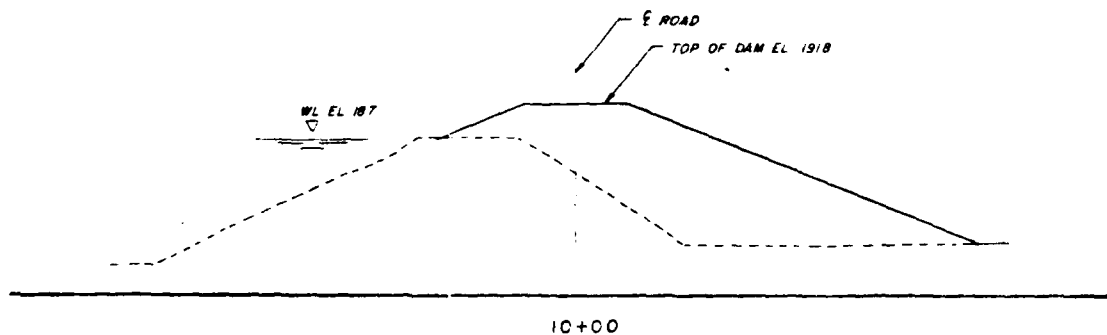
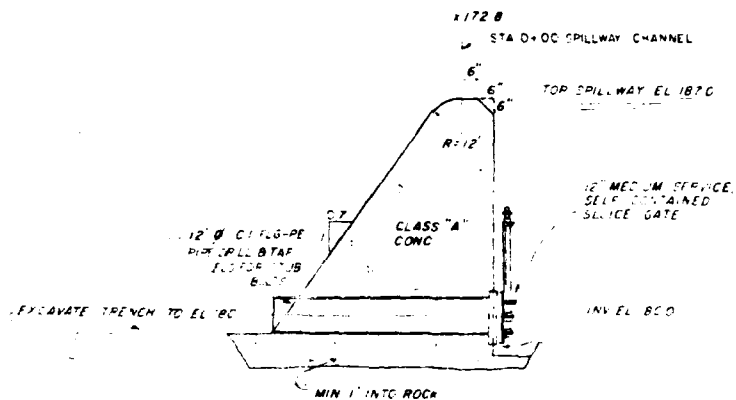
SPILLWAY AND DRAIN DETAIL
SCALE 3/8" = 1'-0"

c. Appurtenant Structures - There are two 12-inch low-level discharge pipes that to pass through the base of the dam. Controls for these pipes are in manholes on the downstream side of the embankment. The location of the outlets could not be found. There is also a discharge pipe through the spillway, but the inlet is silted up and its condition unknown (Plate 2 - Spillway and Drain Detail, Photo 8).

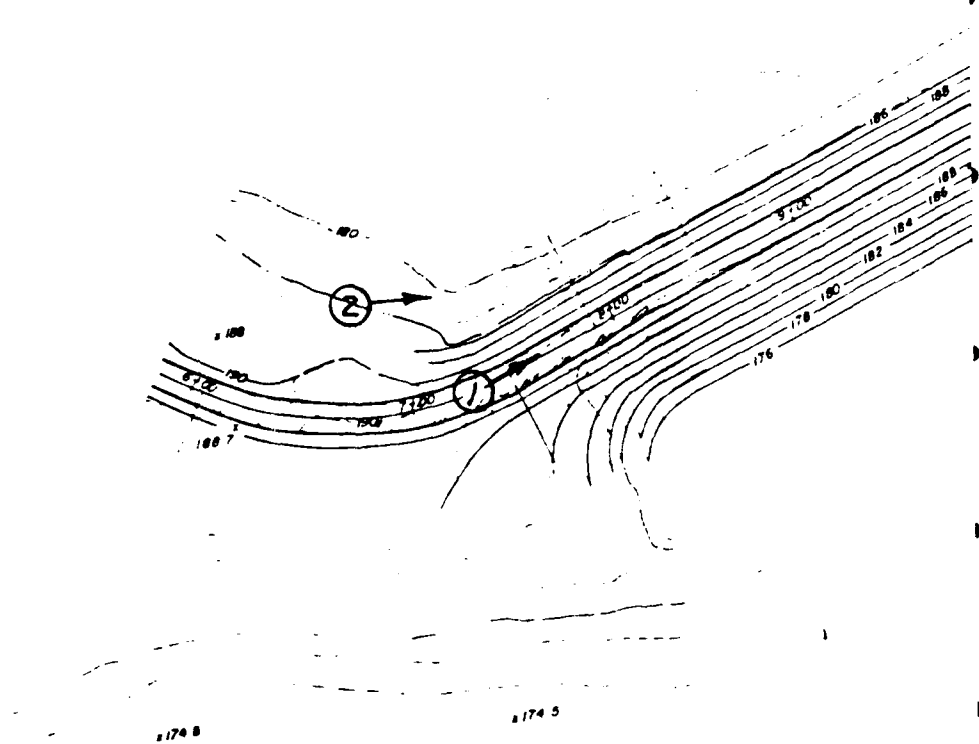
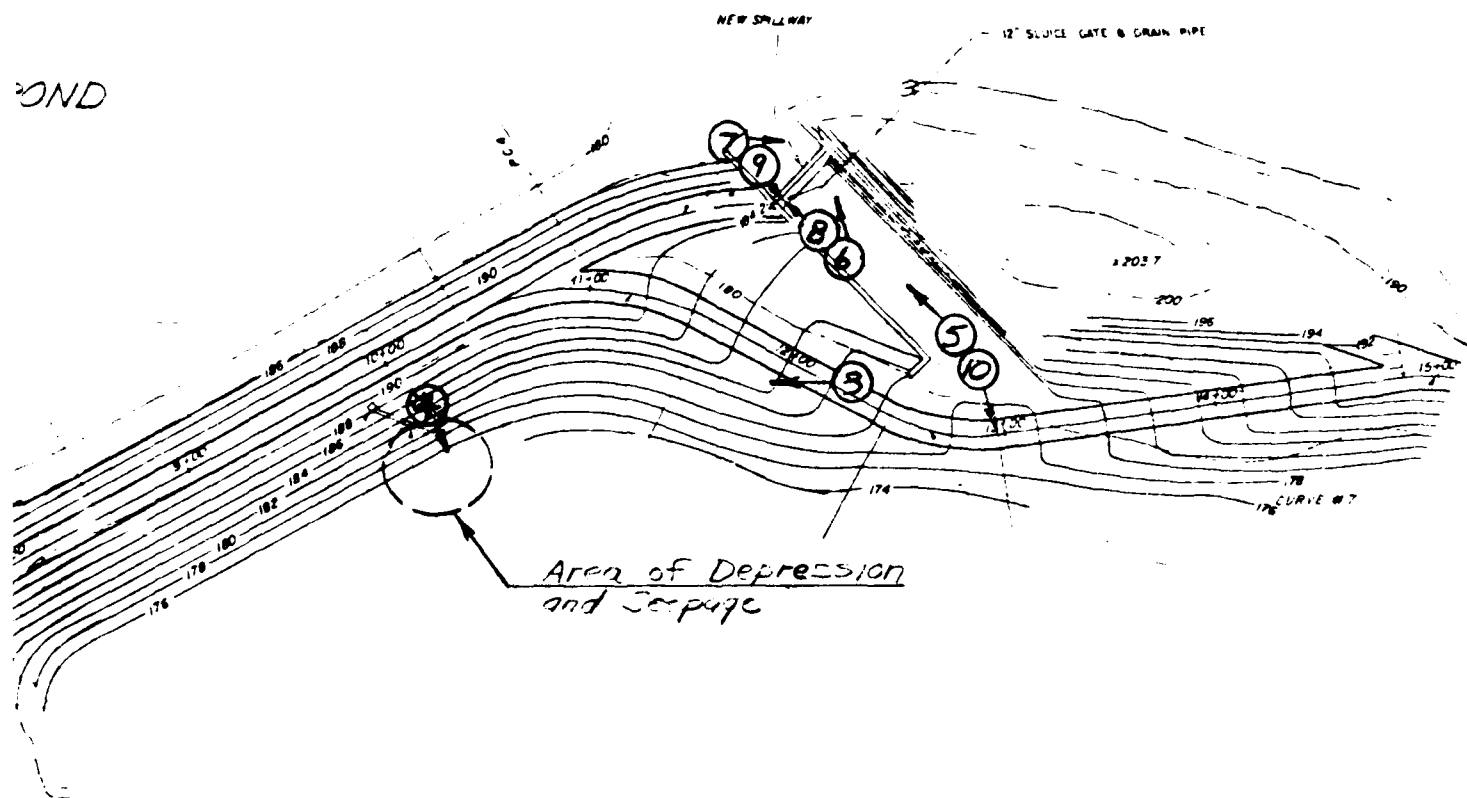
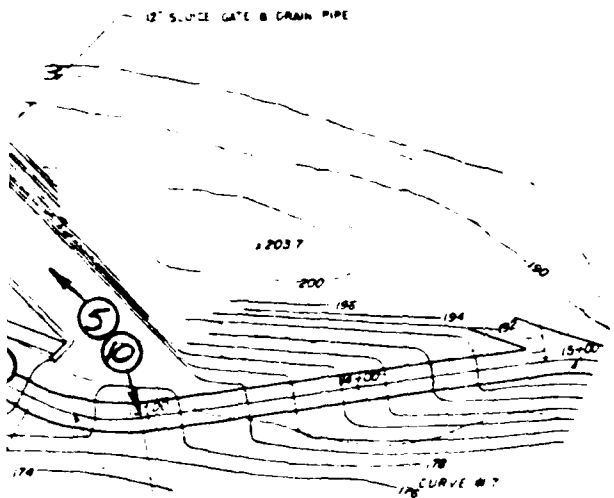
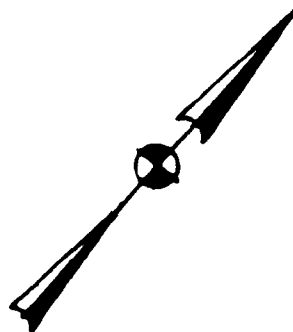
PHOTO LOCATION PLAN

Just below the toe of the dam and in the vicinity of the outlet of the low-level discharge pipes, there is a seepage flow (Photo 4), the amount of which could not be determined (See Photo Location Map - Plate 3 for location). This flow is clear and shows no signs of particle movement. Also, the outlet of the low-level discharge pipes could not be found. However, in the approximate vicinity

where the outlet should be, according to the plans, there is now a depression (Photo 3 - See Location Map - Plate 3 for location).
